AQUATIC LEASE INSPECTION REPORT

LEASE NUMBER: 22-A02332

USE: COMMERCIAL MARINA

LESSEE NAME: SEVEN Js INVESTMENT LIMITED PARTNERSHIP

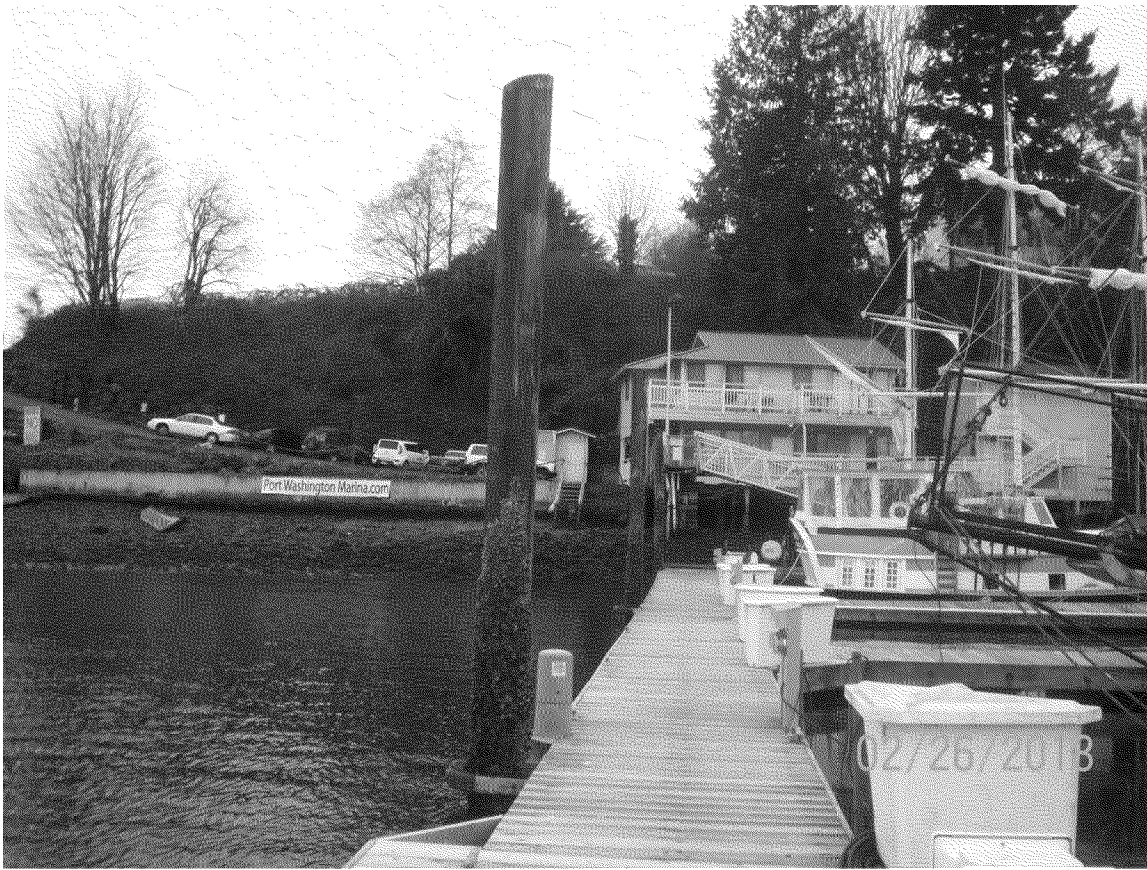
Figure 1: Photo showing the concrete bulkhead, parking area, and two NWD buildings in the background. E-Dock in the foreground

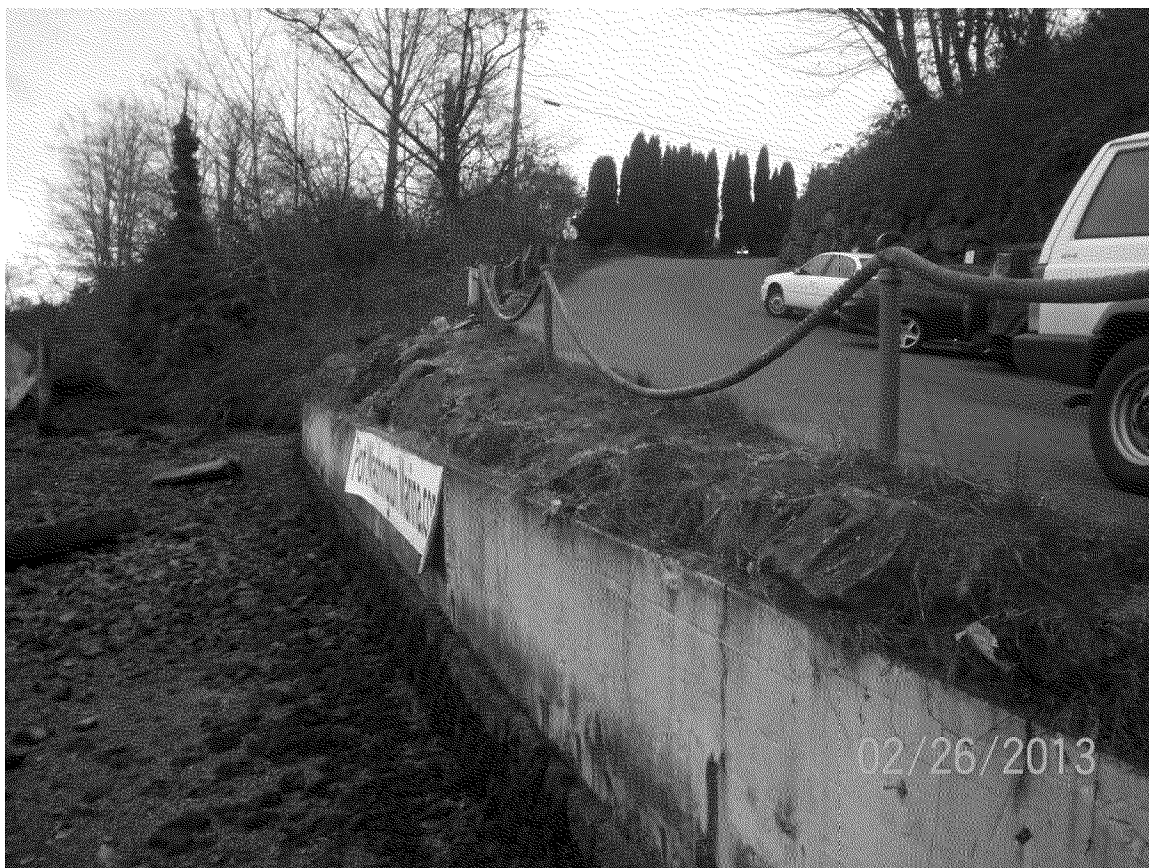
Figure 2: State owned concrete bulkhead and parking lot.

There is a lack of clarity regarding the ownership of the existing improvements. There is a bulkhead and fill owned by the Tenant and a bulkhead and fill owned by the state. **Recommendation:** generate an ownership exhibit that better clarifies the State and Tenant owned property. In the long run, it may be more cost effective for us to divest ourselves of these improvements and have the new tenant purchase the fill and bulkhead since we can't charge extra for these improvements.

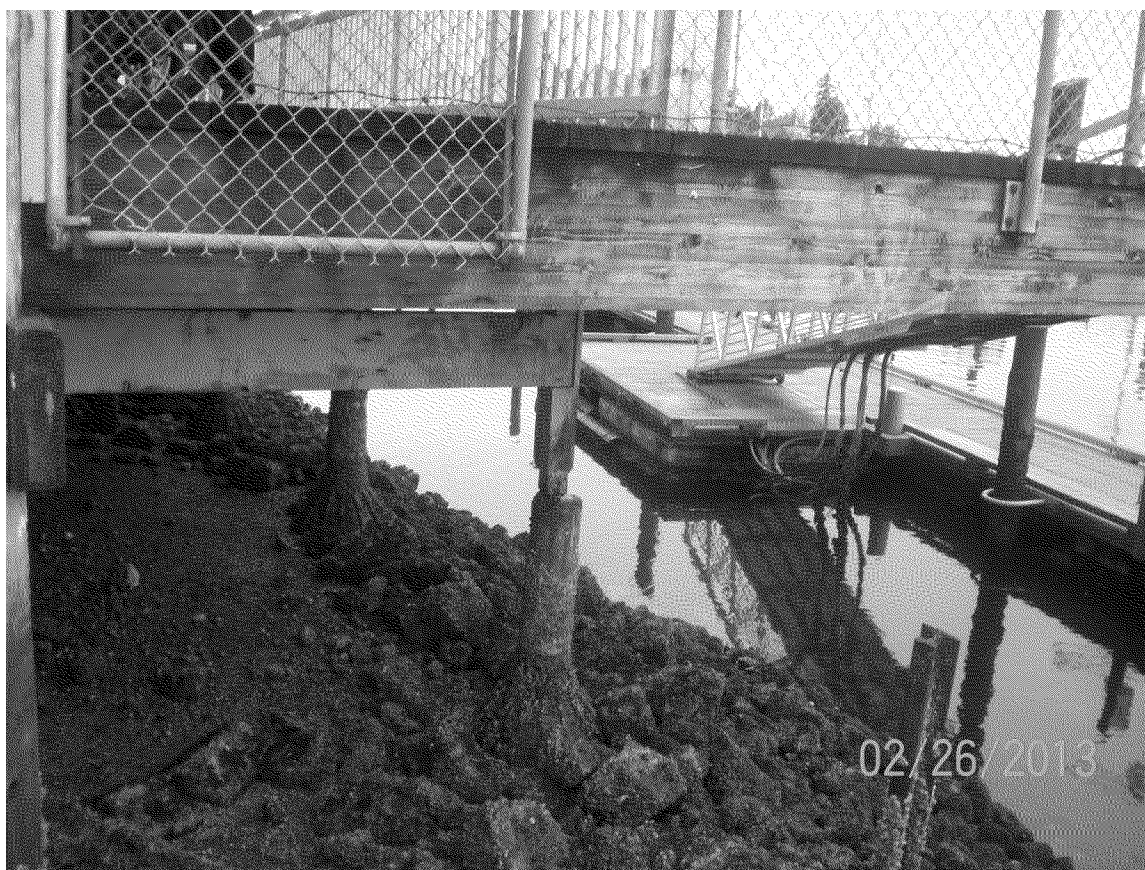
Figure 3: Rip-rap under the marina office building along the shoreline. The angular rip-rap rock is gone in places. The support piles have been modified as shown.

The marina offices are located on private property, filled harbor area, and a pier. The marina office is in one building. The second building has restrooms, showers and laundry facilities for the marina tenants. I made no assessment regarding the structural integrity of the buildings, pier, rip-rap or bulkhead. It would be advisable for a new purchaser to have the structural condition of the improvements evaluated.

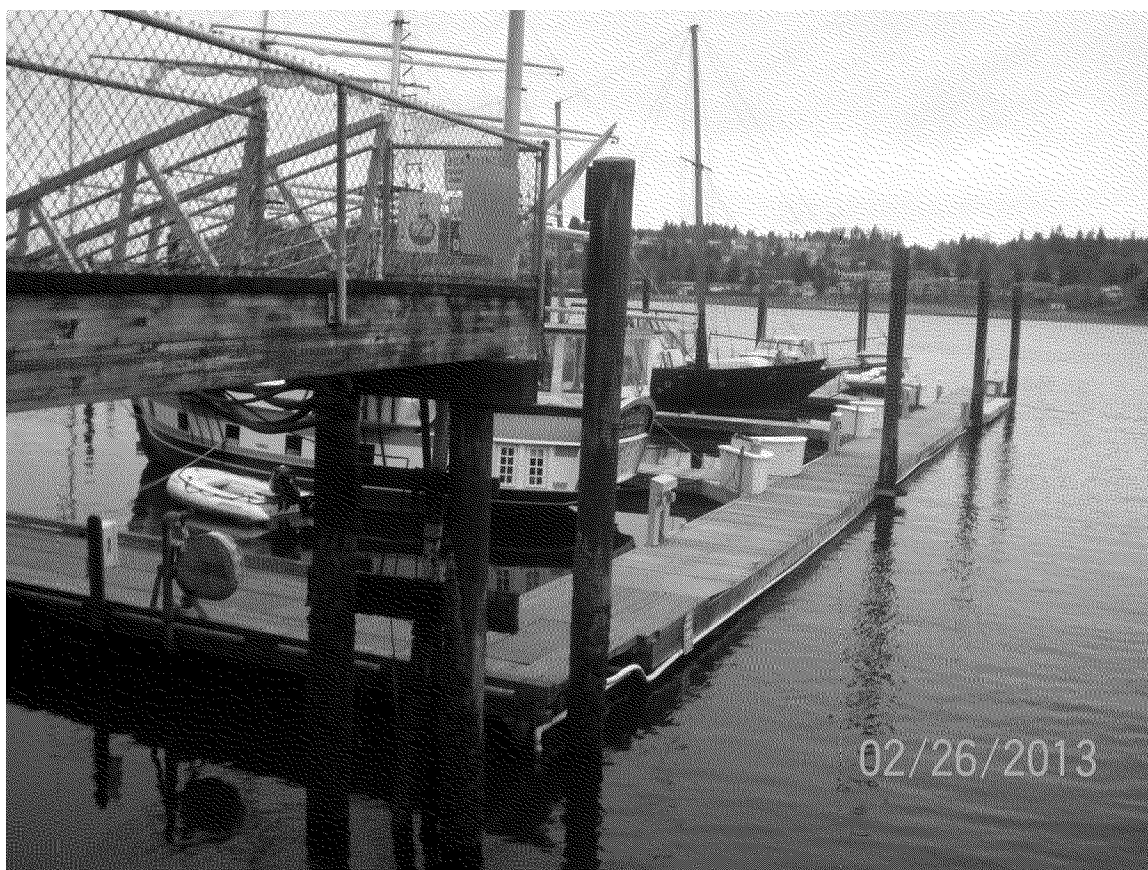
Figure 4: Photo showing Dock-E. The pump-out is located at the end of Dock-E

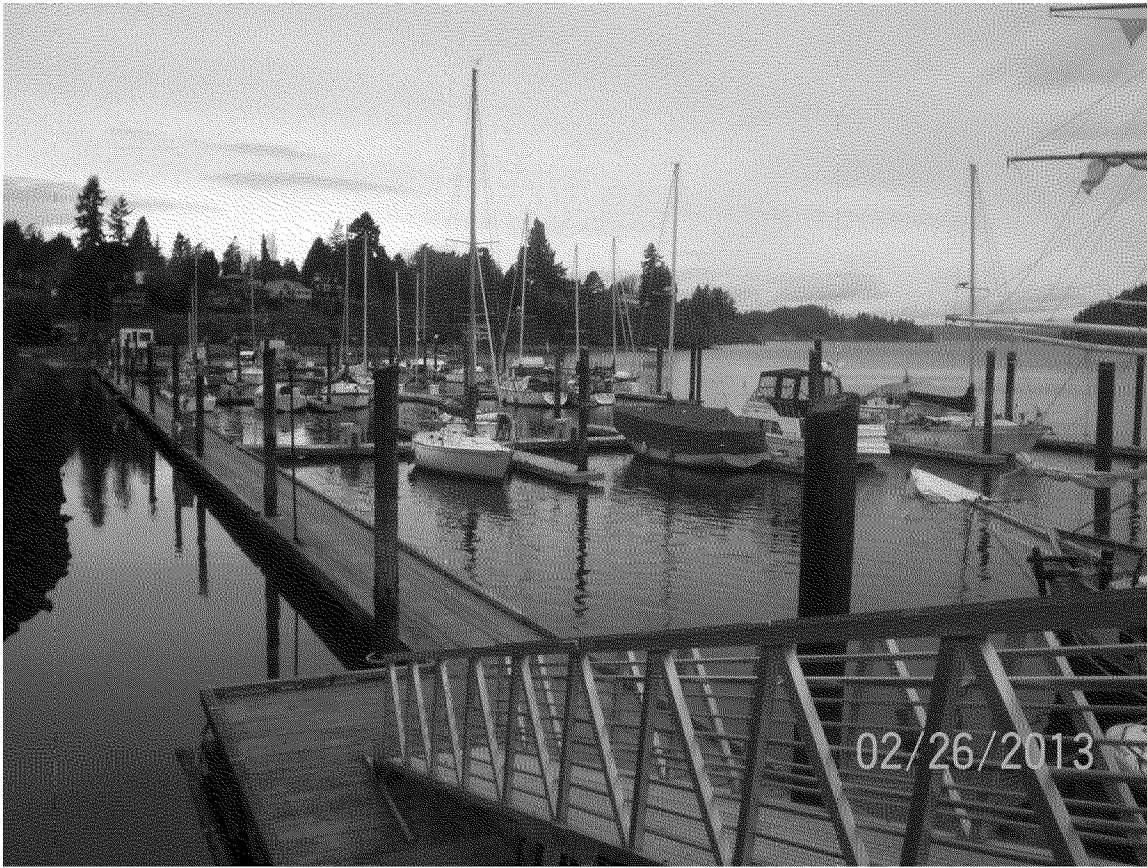
Figure 5: Photo showing the grated metal gangway in the foreground. The Main-Dock is shown connecting Dock-D in the foreground and Dock-A in the background. The floating home on Dock-A can be seen on the left in the background. The main utility lines run down the center of the Main-Dock

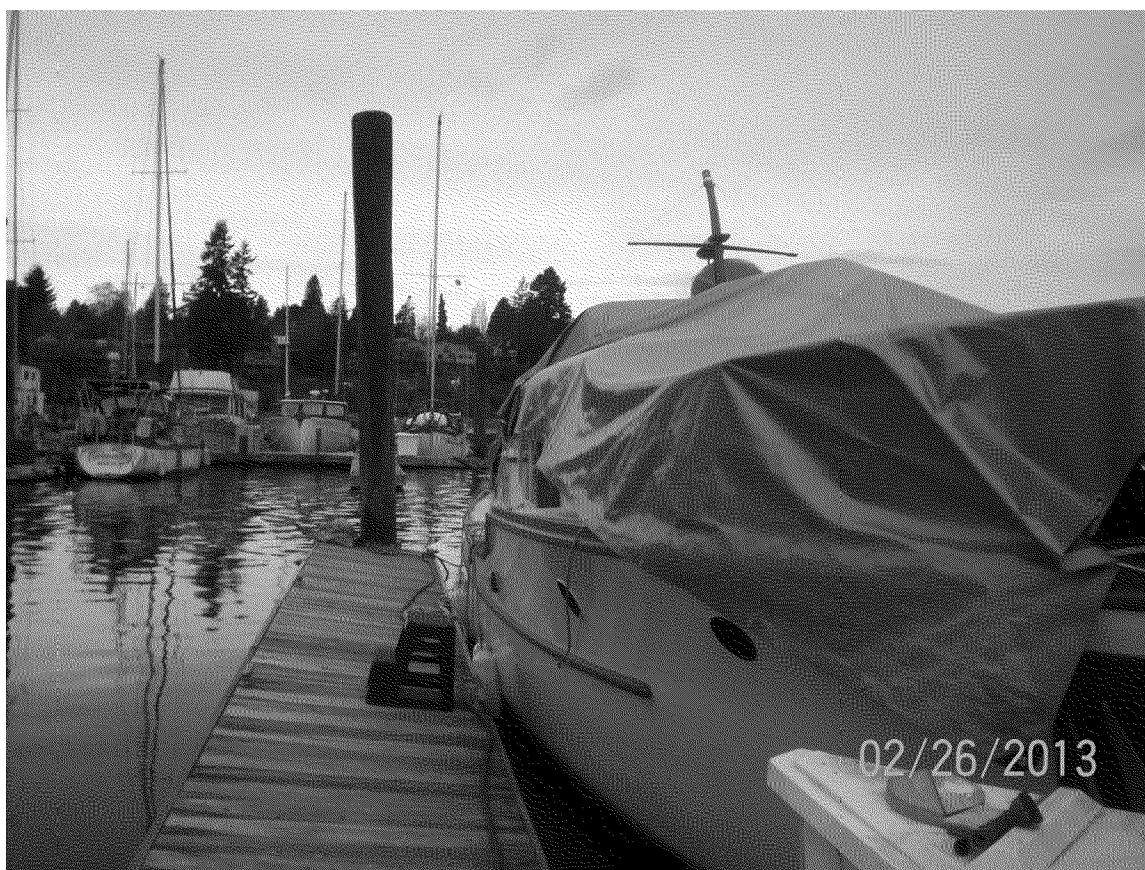
While at the marina many of the floats were observed to be listing. **Recommendation** – the floats be maintained so they are level and no exposed foam remains.

Figure 6: Photo showing the moorage at the end of Dock-D. The dock can be seen listing towards the vessel. Several other finger-piers have pronounced list.

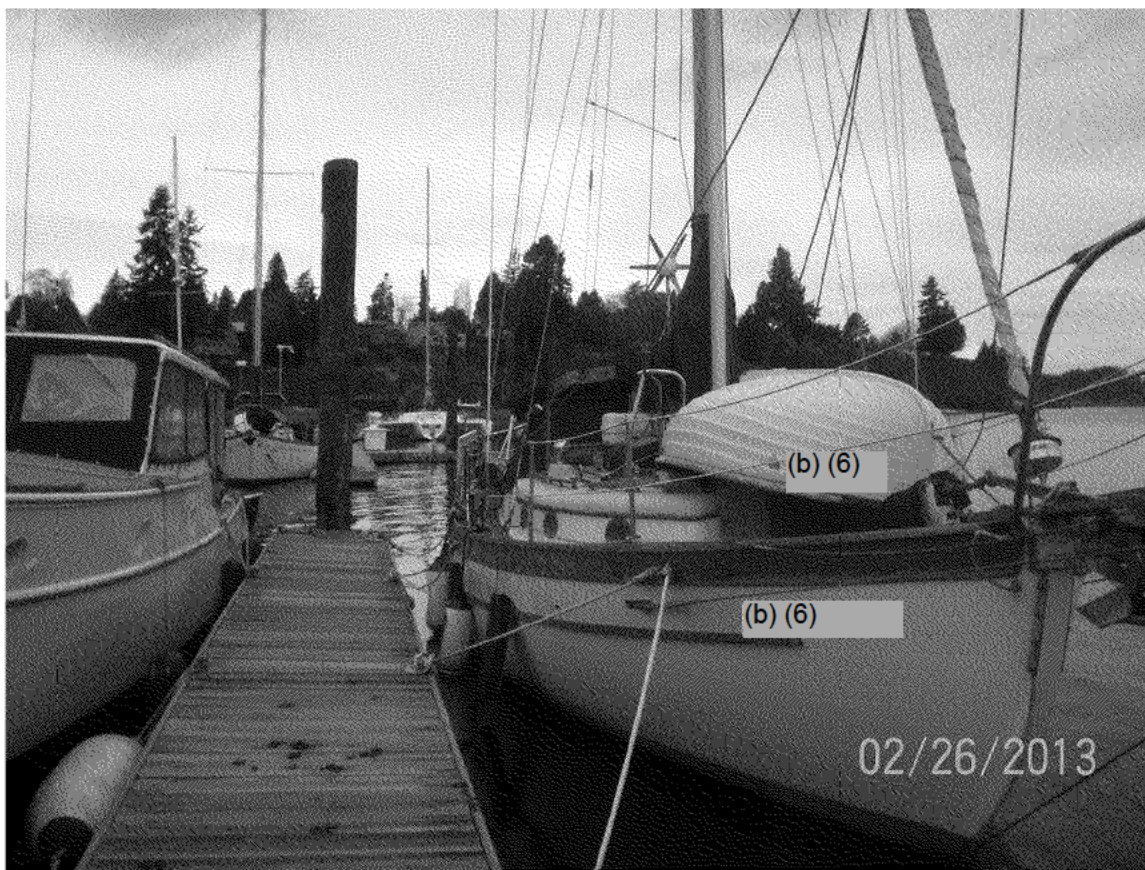
Outer Harbor Line: State Constitution and law do not allow DNR to rent the area outside the outer harbor line to private entities. Some of the marina improvements are shown extending beyond the outer harbor line. The marina is currently mooring vessels outside the outer harbor line. – **Recommendation:** have the marina move tenants inside the outer harbor line. Have the tenant remove the anchor cleats to prevent moorage outside the outer harbor line. Modify the lease, or maybe send a letter, to specify that the improvements need to be removed from the area outside the outer harbor line in conjunction with marina replacement/repairs. Potentially, charge a U&O for the area extending beyond the outer harbor line at the WD rent rate.

Figure 7: Photo showing moorage at the end of Dock-B (foreground) and Dock-A (background). These vessels are clearly moored beyond the outer harbor line.

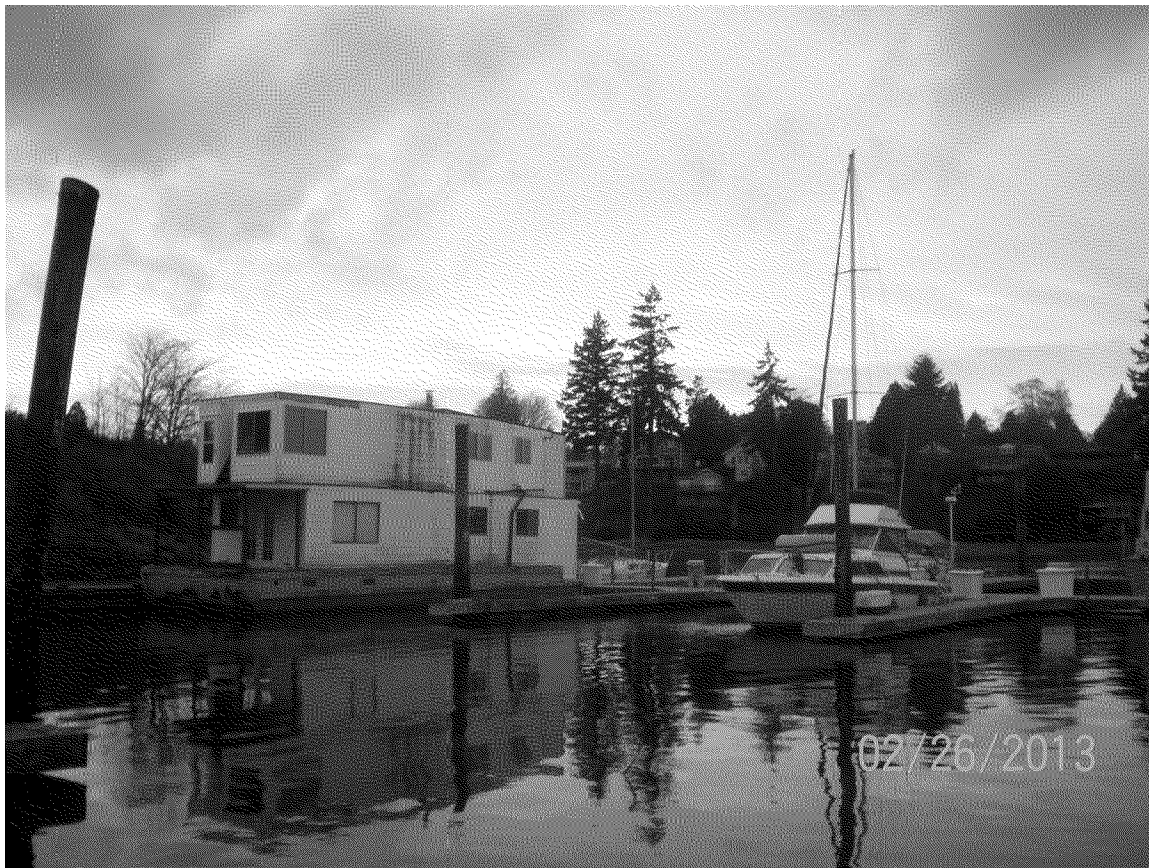
Floating Homes: Floating Homes are not allowed within Harbor Areas. The existing contract allows for an unoccupied floating home which was constructed on a barge. The floating home is derelict and in the process of being seized by the marina for non-payment of rent– **Recommendation:** Amend the contract to make it clear that floating homes are not allowed within the harbor area. An occupied floating home will not be allowed. Require the existing derelict floating home to be completely removed from the leasehold once the marina has ownership of the floating home.

Figure 8: Photo showing the floating home on Dock-A. The floating home is in poor condition.

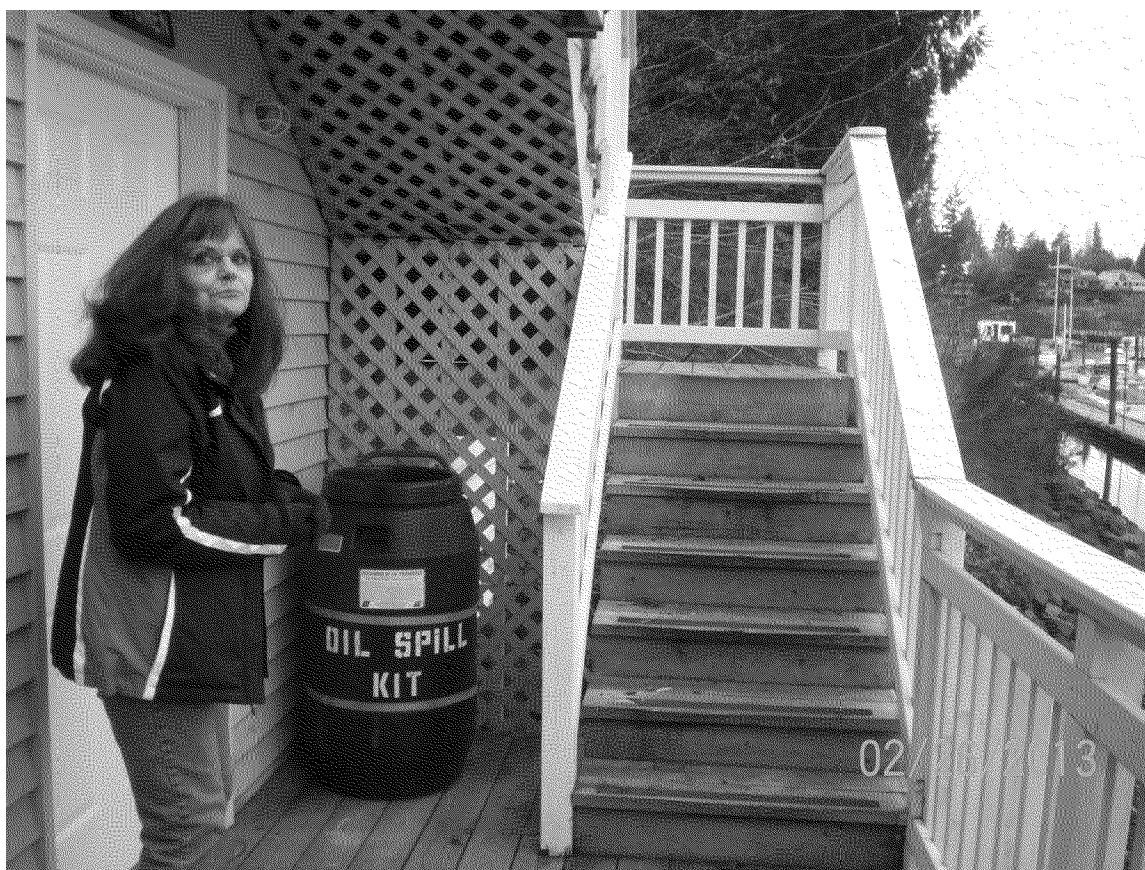
Figure 9: Photo showing the oil spill kit which is located on the pier near the restroom building.
